National Register of Historic Places  
Registration Form

historic name Maryland Tuberculosis Sanatorium Administration Building  
other names/site number Cullen, Victor, Center Old Administration Building (preferred) ~~F-16-21B~~

Victor Cullen Center Old Administration Building  
Frederick County, Maryland F-6-21B

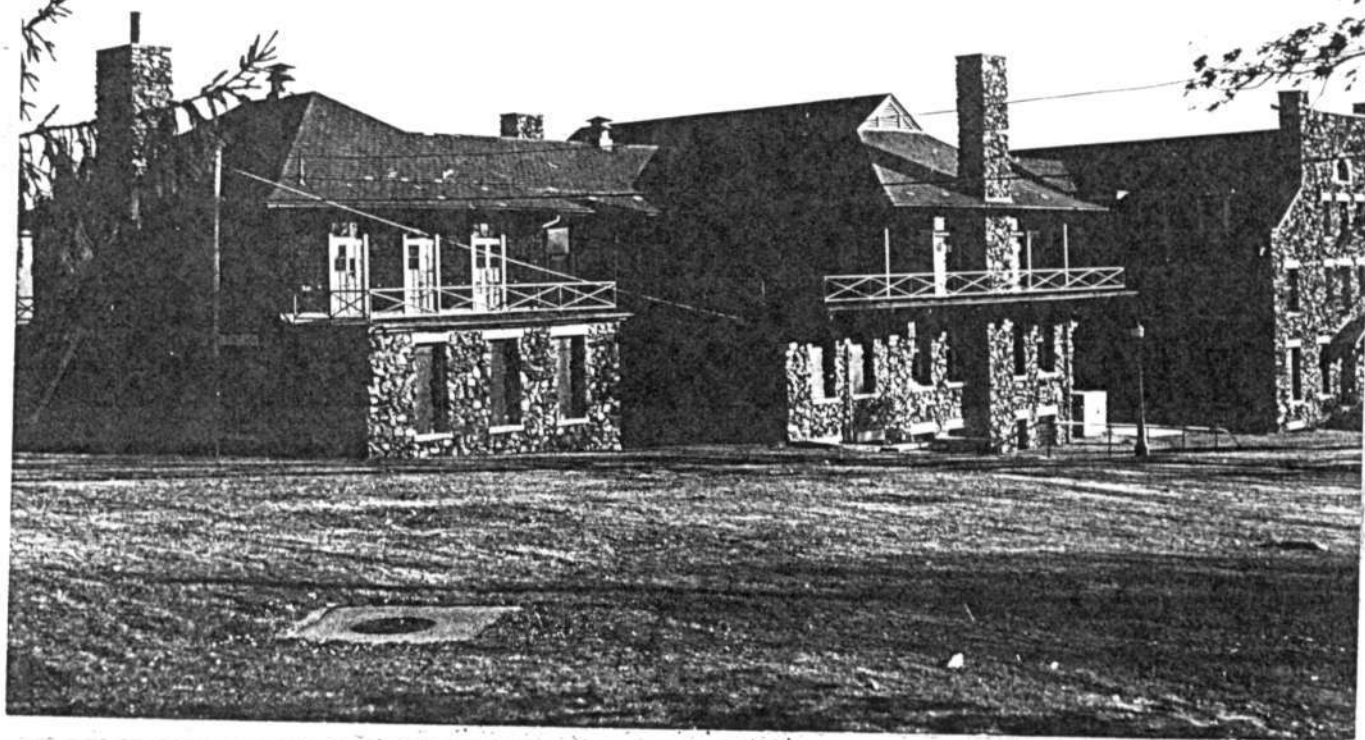
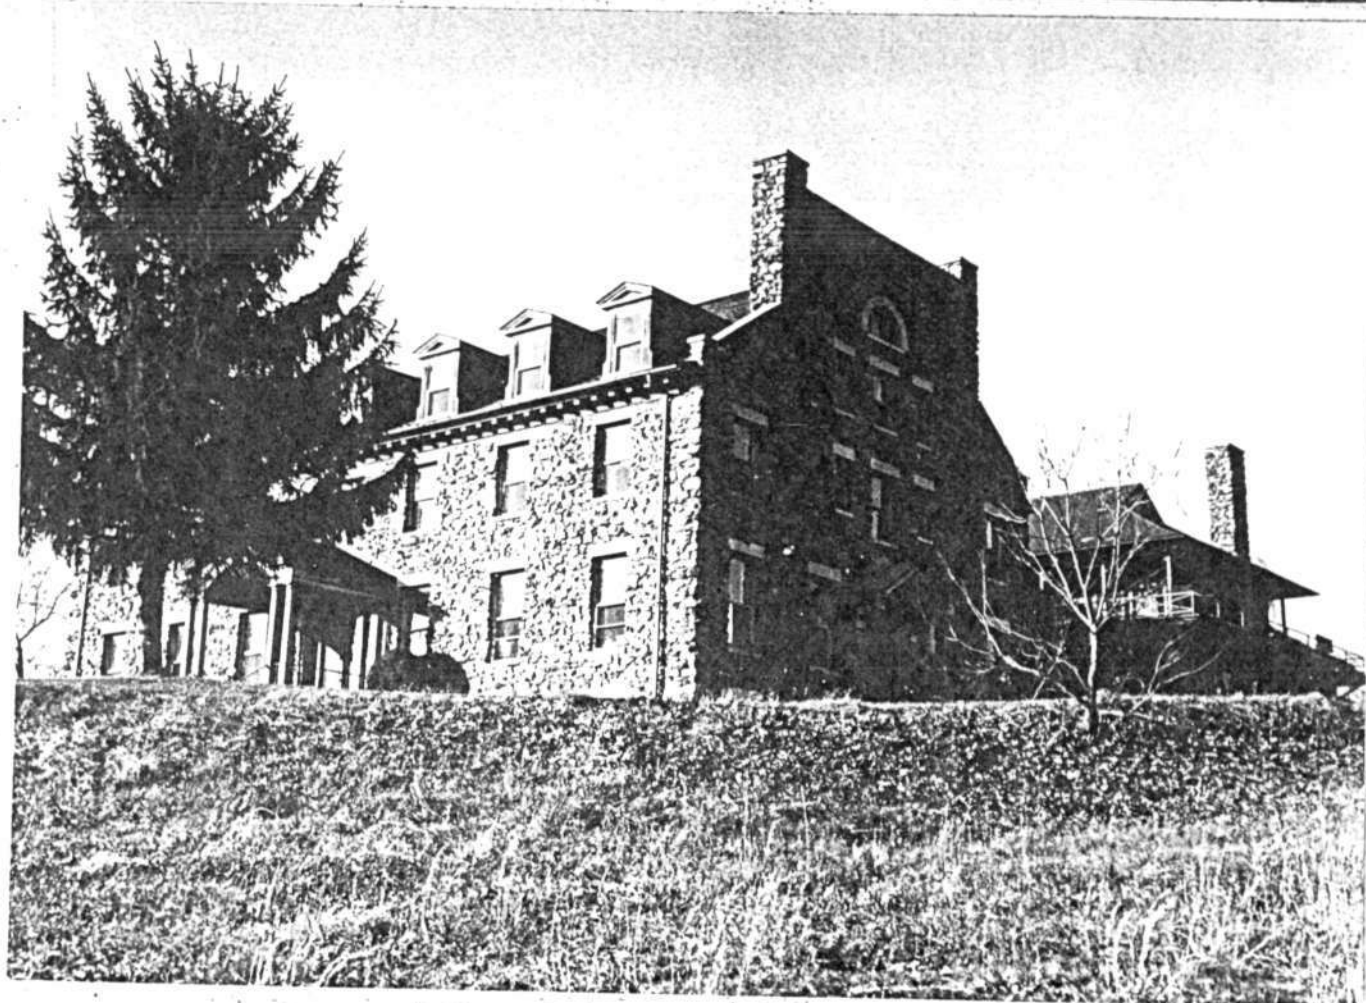
7/13

Callen, Victor, Center Old Administration Building  
Frederick County, MD  
23 November 1988  
Photo: Ronald L. Andrews  
Neg: MD SMP2  
Northwest elevations

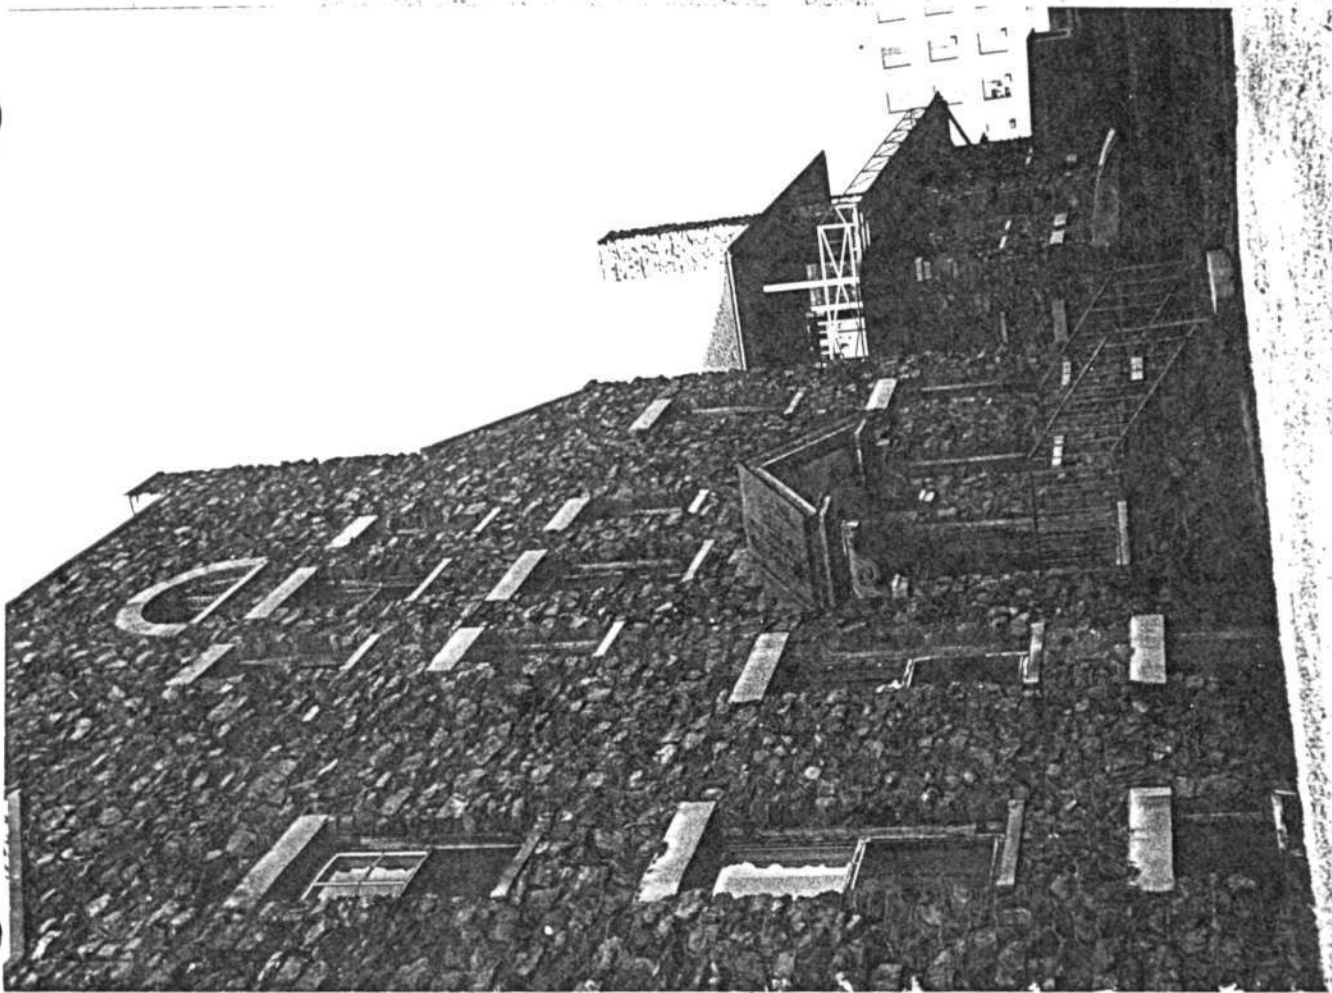
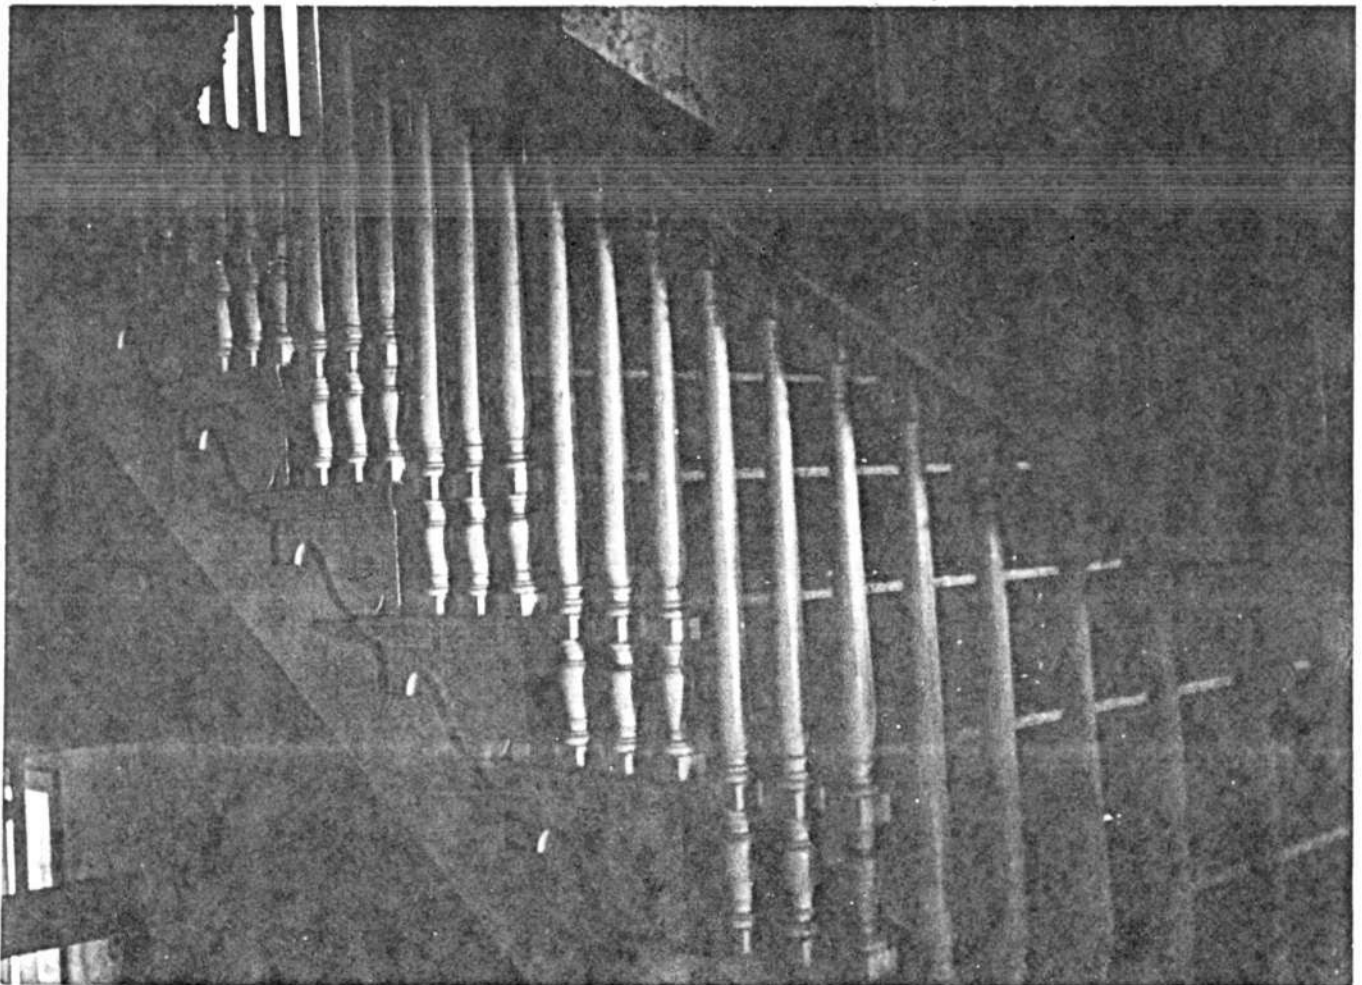
9/  
13

Cullen, Victor, Center Old Administration Building  
Frederick County, MD  
23 November 1988  
Photo: Ronald L. Andrews  
Neg: MD SHPO  
Elevation detail

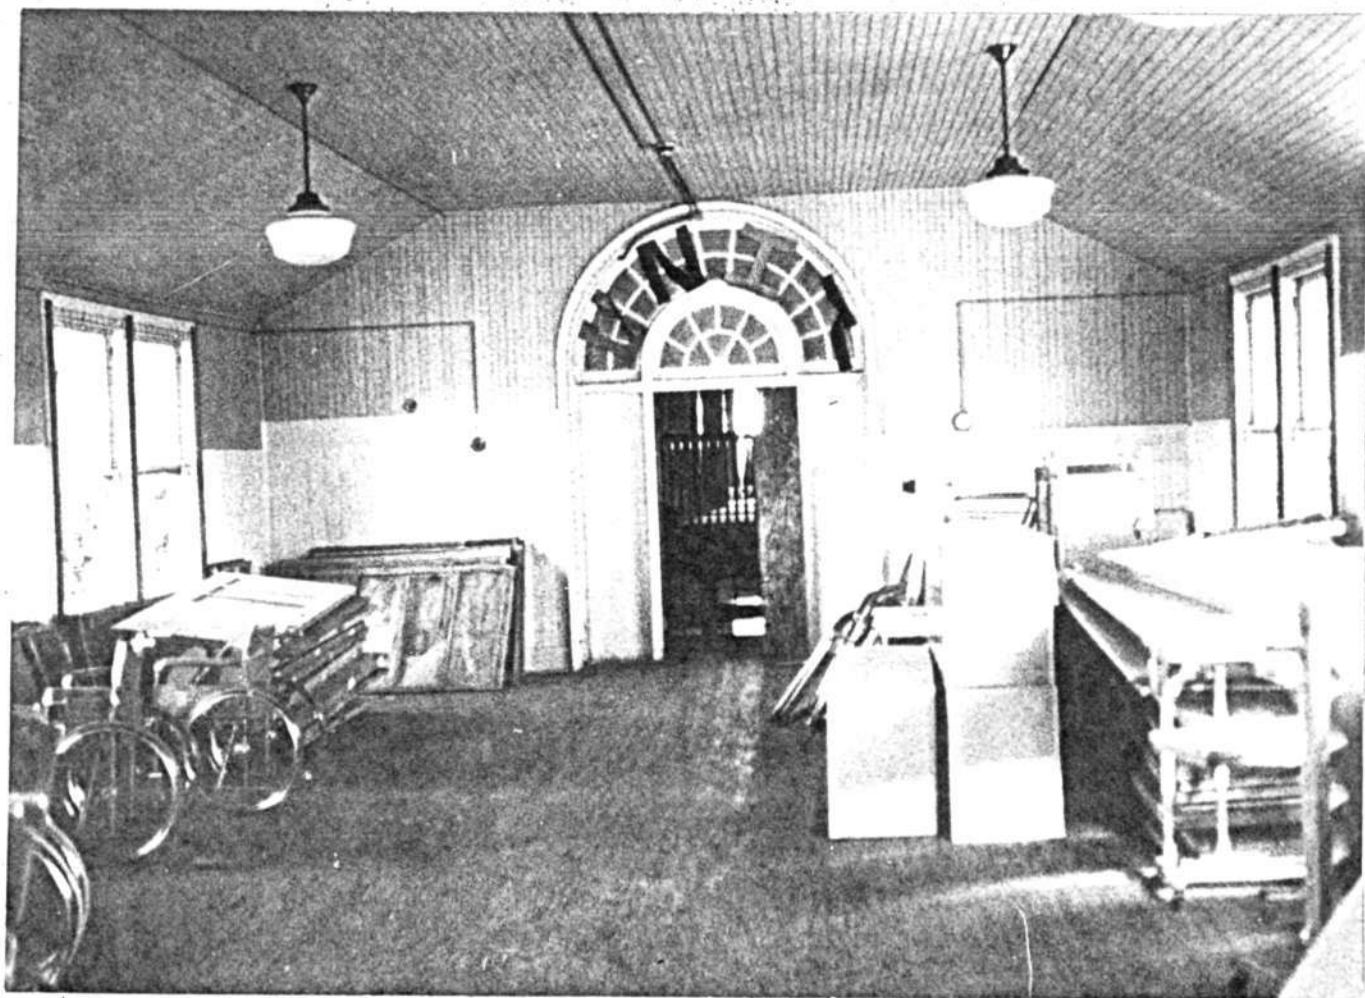
13/  
13

Cullen, Victor, Center Old Administration Building  
Frederick County, MD  
25 November 1988  
Photo: Ronald L. Andrews  
Neg: MD SHPO  
Interior, 2nd Floor room

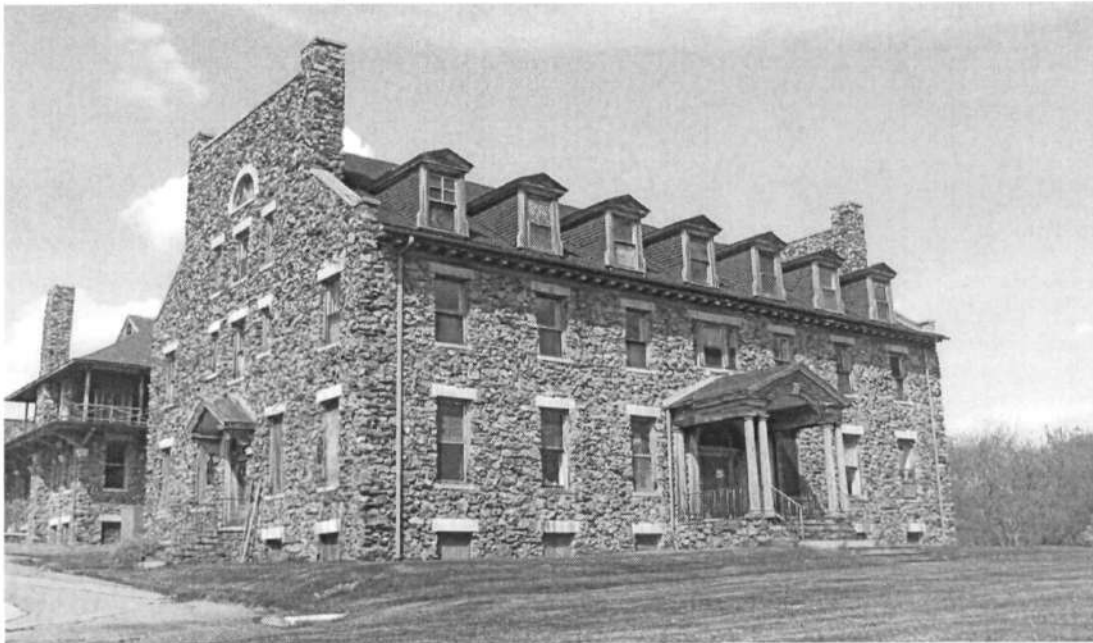
South and west facades

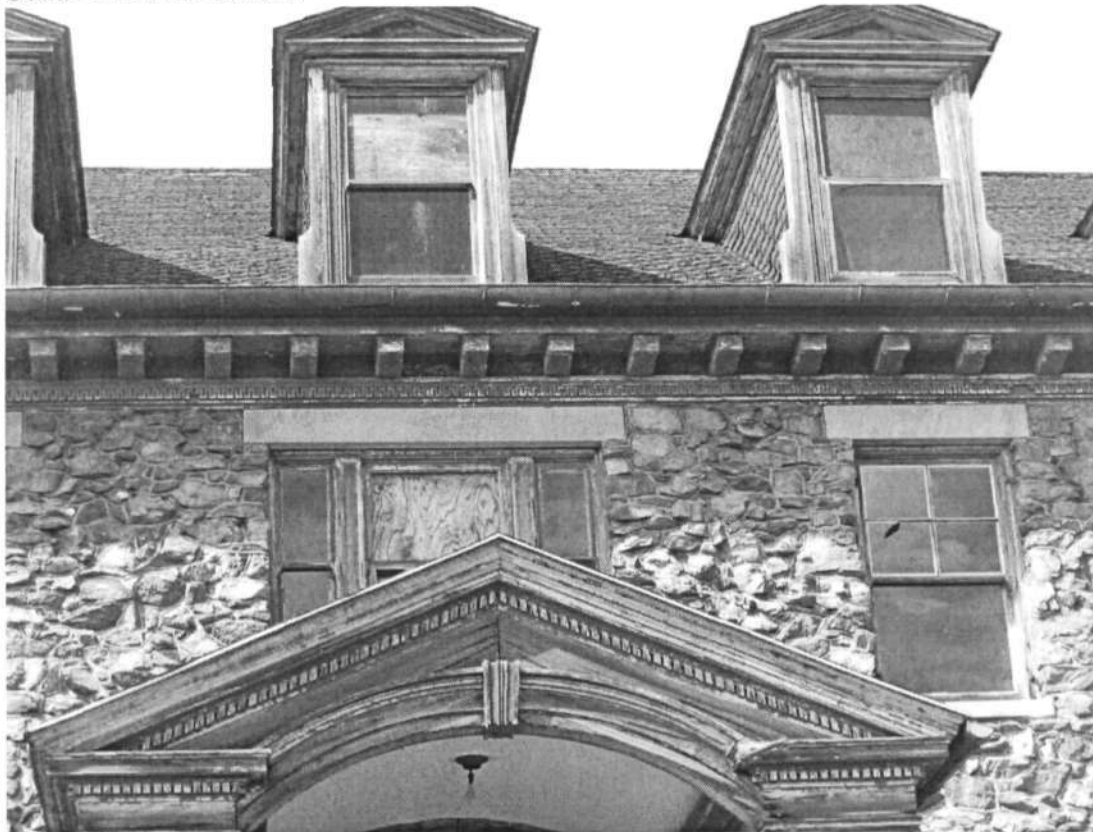
Detail, south facade

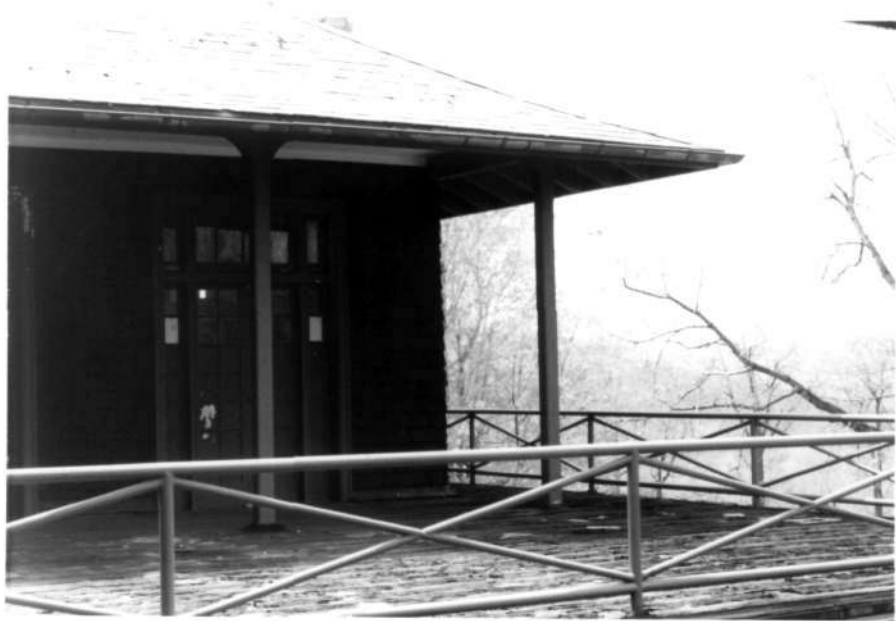
F-6-21B  
DJA  
Mar, 1978

Administration Bldg  
2<sup>nd</sup> floor infirmary  
over dining room

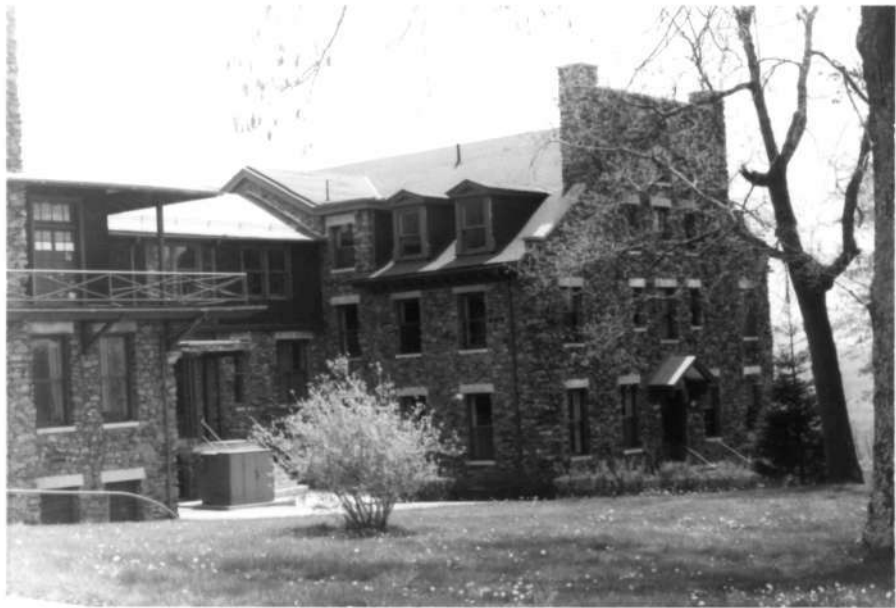
F6-230

Rear of Administration Bldg

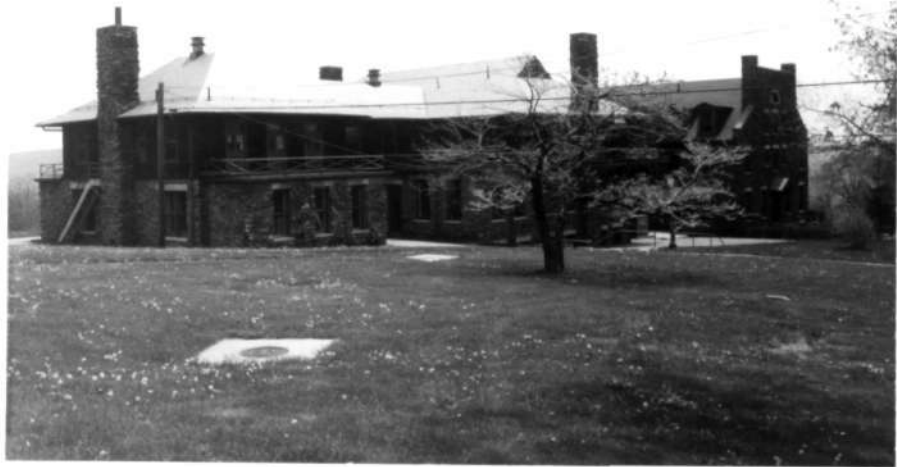
5-6-21B

Nld. TB Sanatorium  
Adm. Bldg & Dining Room

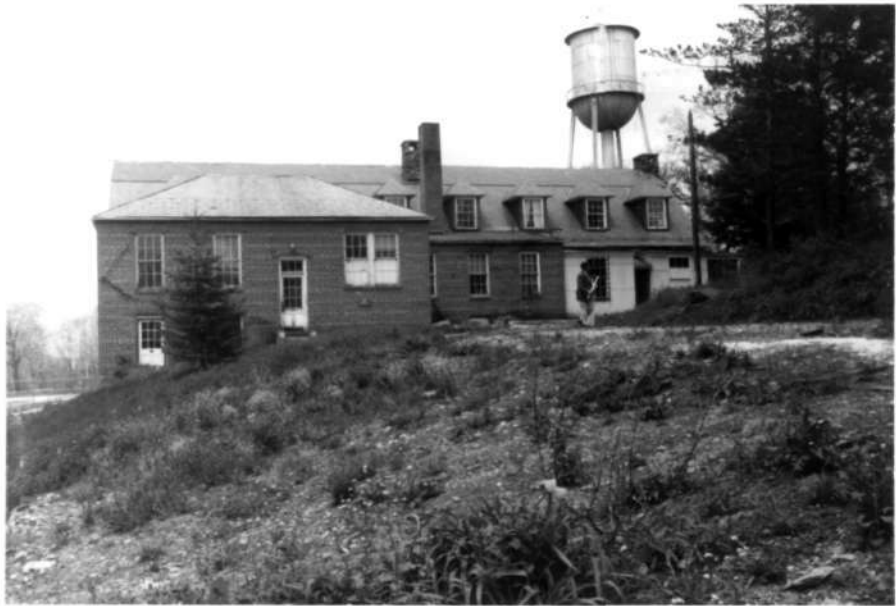
F-6-21B

Reception Hospital Kitchen  
and Dining Room

which opened in August of 1912 with 200 beds, 100 in private rooms, was built for more advanced cases. At that time the boiler capacity of the power plant was doubled with a new Fitzgibbons boiler. The hospital wing has been demolished, but part of the kitchen and dining facilities remain but in poor condition.
